Case 251 : Narrative

Case Vehicle (A): 1999 Mercury	Vehicle (B): 1999 Ford
Type: Grand Marquis LS, 4-door sedan	Type: F150 Supercab Pickup 4x4
Driver: 73-year-old female	Driver: 28-year-old male
CDC: 12-FDEW-2	CDC: 99-0000-0

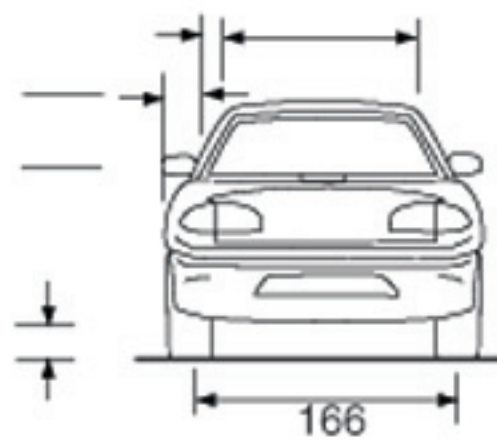
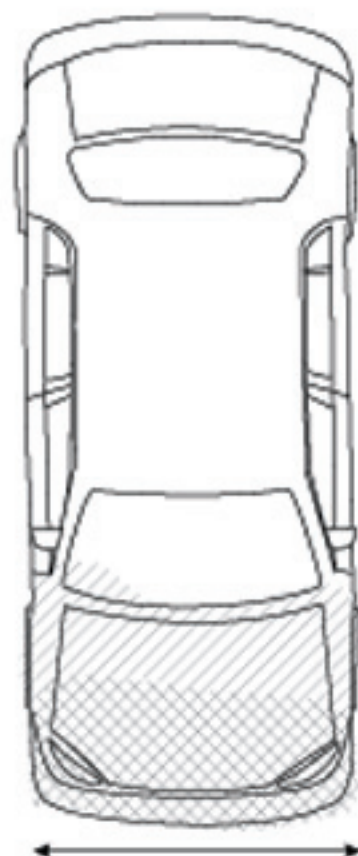
150 cm
direct damage
60 cm max crush
above the bumper

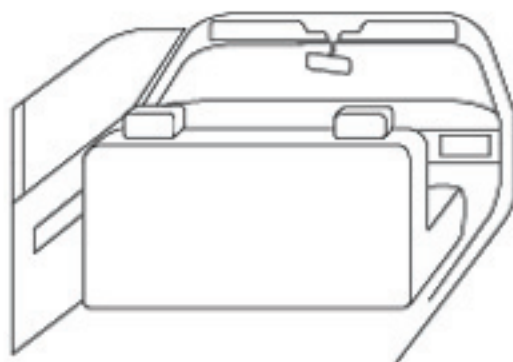
DR belt: positioned low on B-pillar

Evidence of belt use: yes -
marks on webbing
light scratches on D-ring

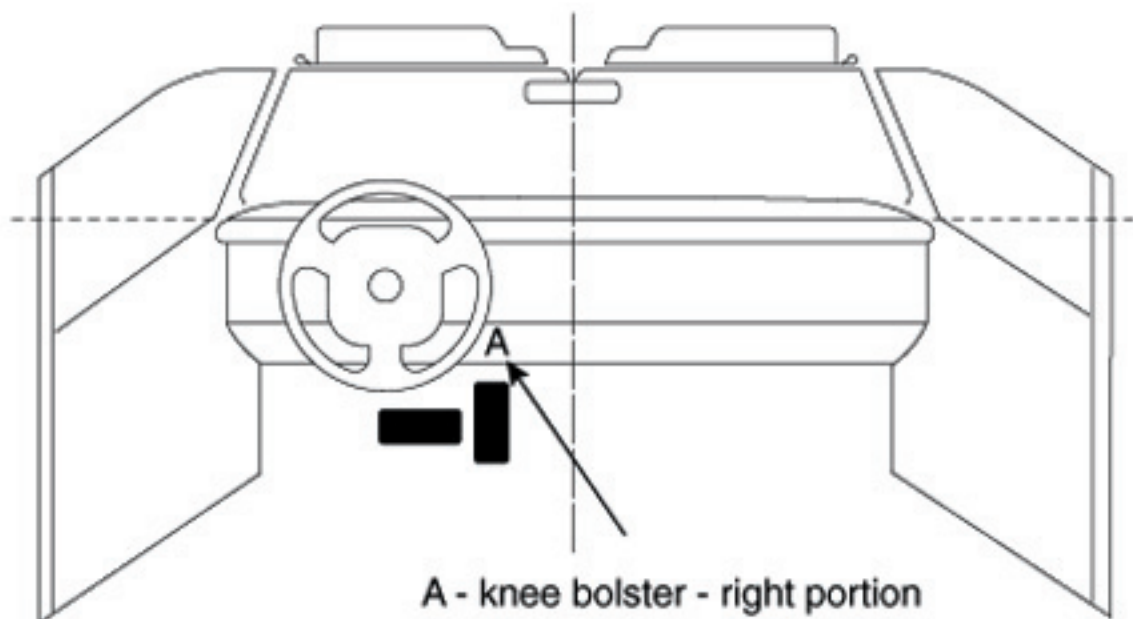
A - knee bolster - right portion
(3x2 cm scuff mark)
